Technical Memorandum 2

Existing Conditions Review

Accessible, well-marked bus stops are one of the foundational elements of an effective fixed route service. The C-SMMPO requested the assistance of a consultant to conduct a physical inventory of all bus stops within its borders. The field survey was undertaken to:

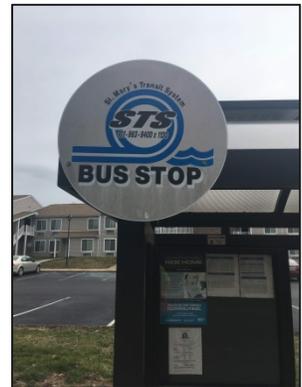
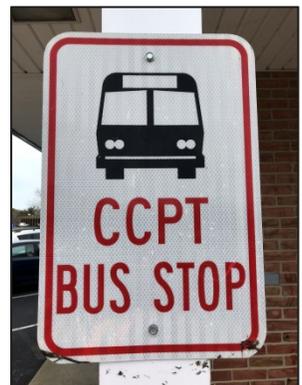
Of the 111 surveyed stops, only four had any signage indicating that the respective transit provider stopped there. Of the four, three of the stops were served by STS, while the remaining stop was served by CCPT. The three STS signs were attached to shelters, while the CCPT sign was attached to a brick column outside the Southern Branch of the Calvert County Library System. The rest of the stops were unmarked flag stops.

In order to be considered ADA Compliant, bus stop signs must be greater than 80 inches tall or protrude less than four inches from the surface it is attached to. All four signed stops fulfilled these guidelines.

During the field survey, it was noted that the STS bus stop signs were more detailed than the CCPT signs, including a phone number and more noticeable branding elements. Having informative and distinctly designed signage makes both the bus stop and the transit system more visible and provides a direct line for customers to contact the transit agency with any questions or concerns about the system’s performance.

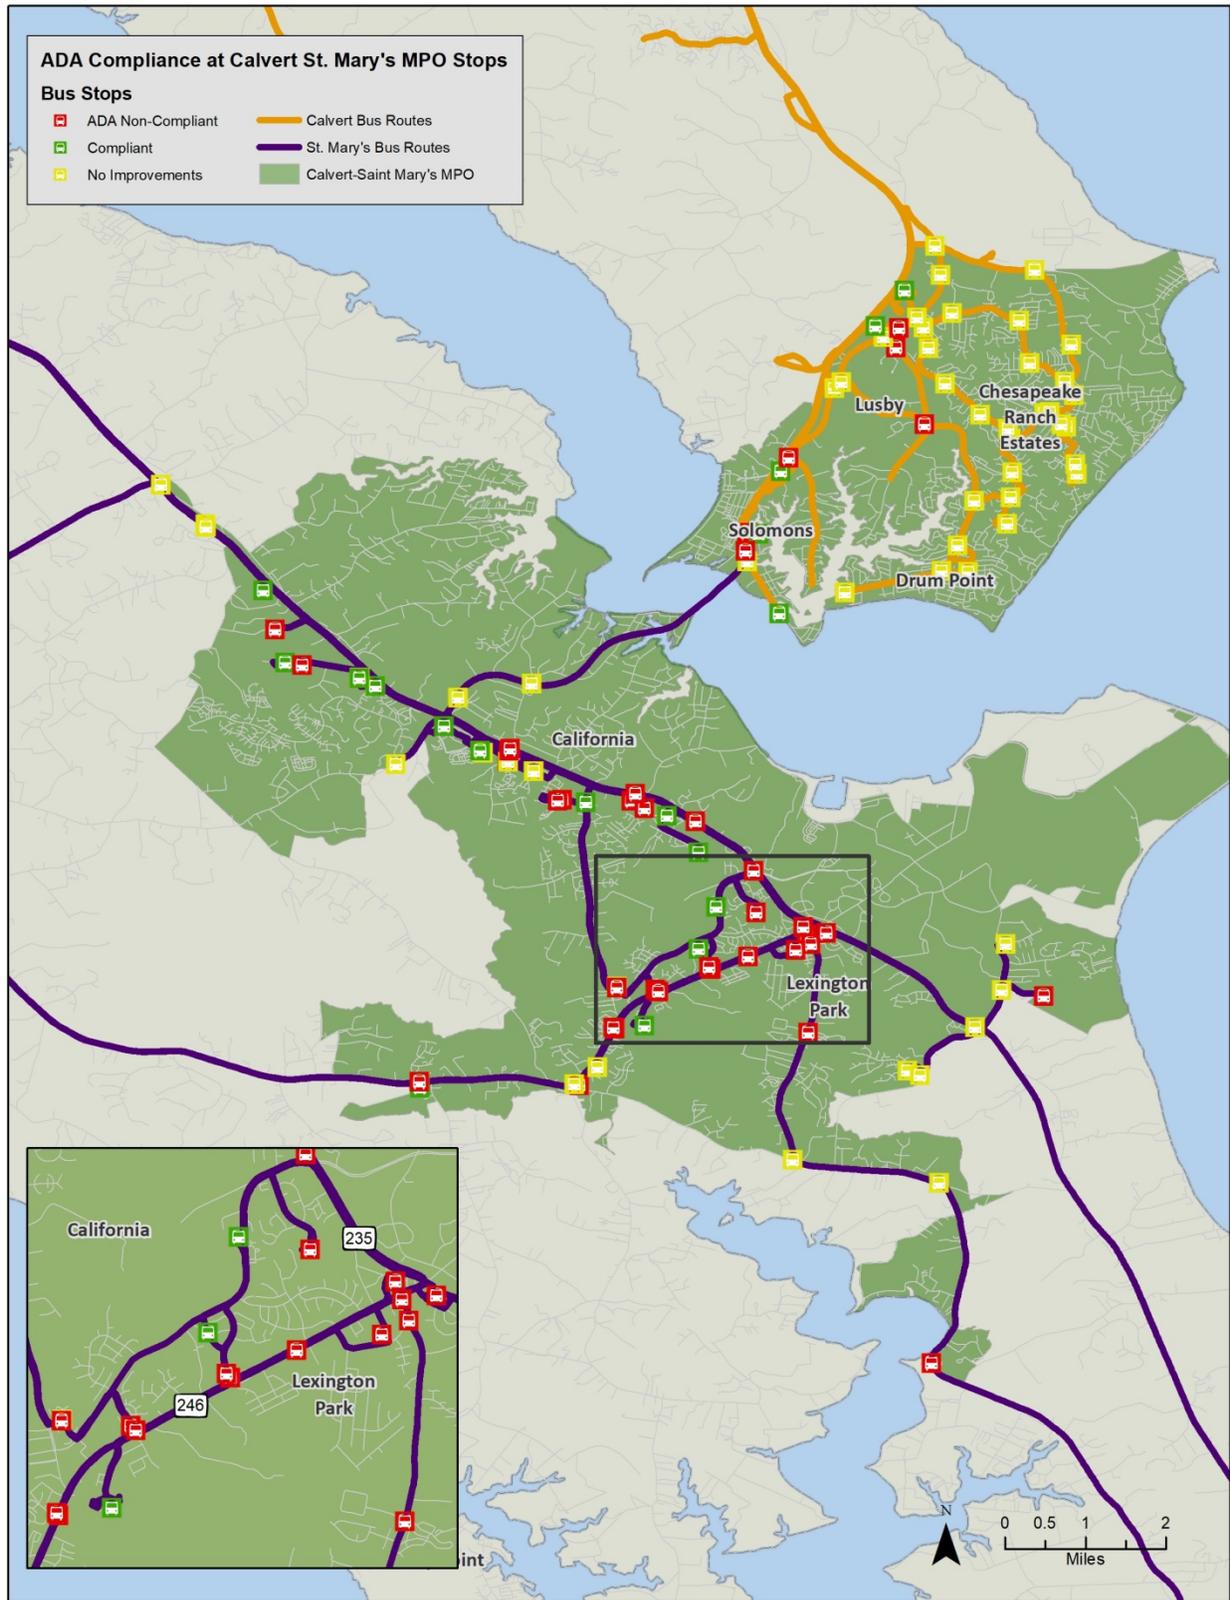
Figure 2-2: C-SMMPO Bus Stops by ADA Compliance Guidelines

Figure 2-2 shows the distribution of the inventoried stops within C-SMMPO’s boundaries, categorized by ADA compliance. Nearly all of the stops in Chesapeake Ranch Estates were classified as no improvements, meaning that there is very little pedestrian infrastructure within the largely residential community. Along major roads (Three Notch Road, Great Mills Road, etc.) in St. Mary’s County, many stops were non-compliant, mostly due to a lack of proper boarding areas.

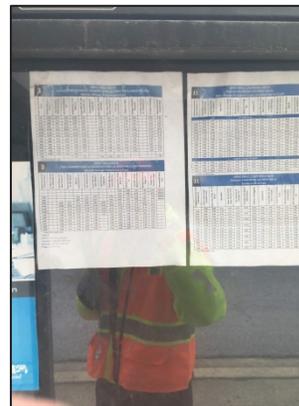
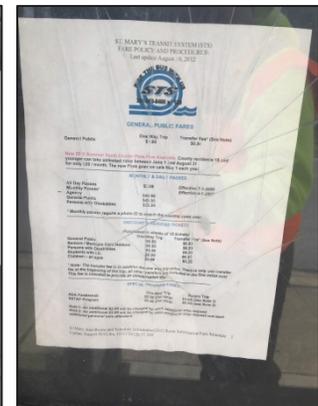
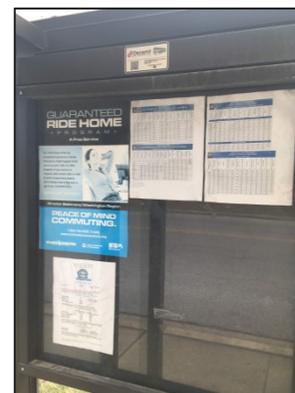
Of the 111 observed stops, 2 had information cases. All stops with information cases were served by STS. Each case was a one sided rectangular glass panel. They both included route schedules, fare information, and contact information. Each information box was located within a shelter. One case was damaged with visible scratches on the glass panel.

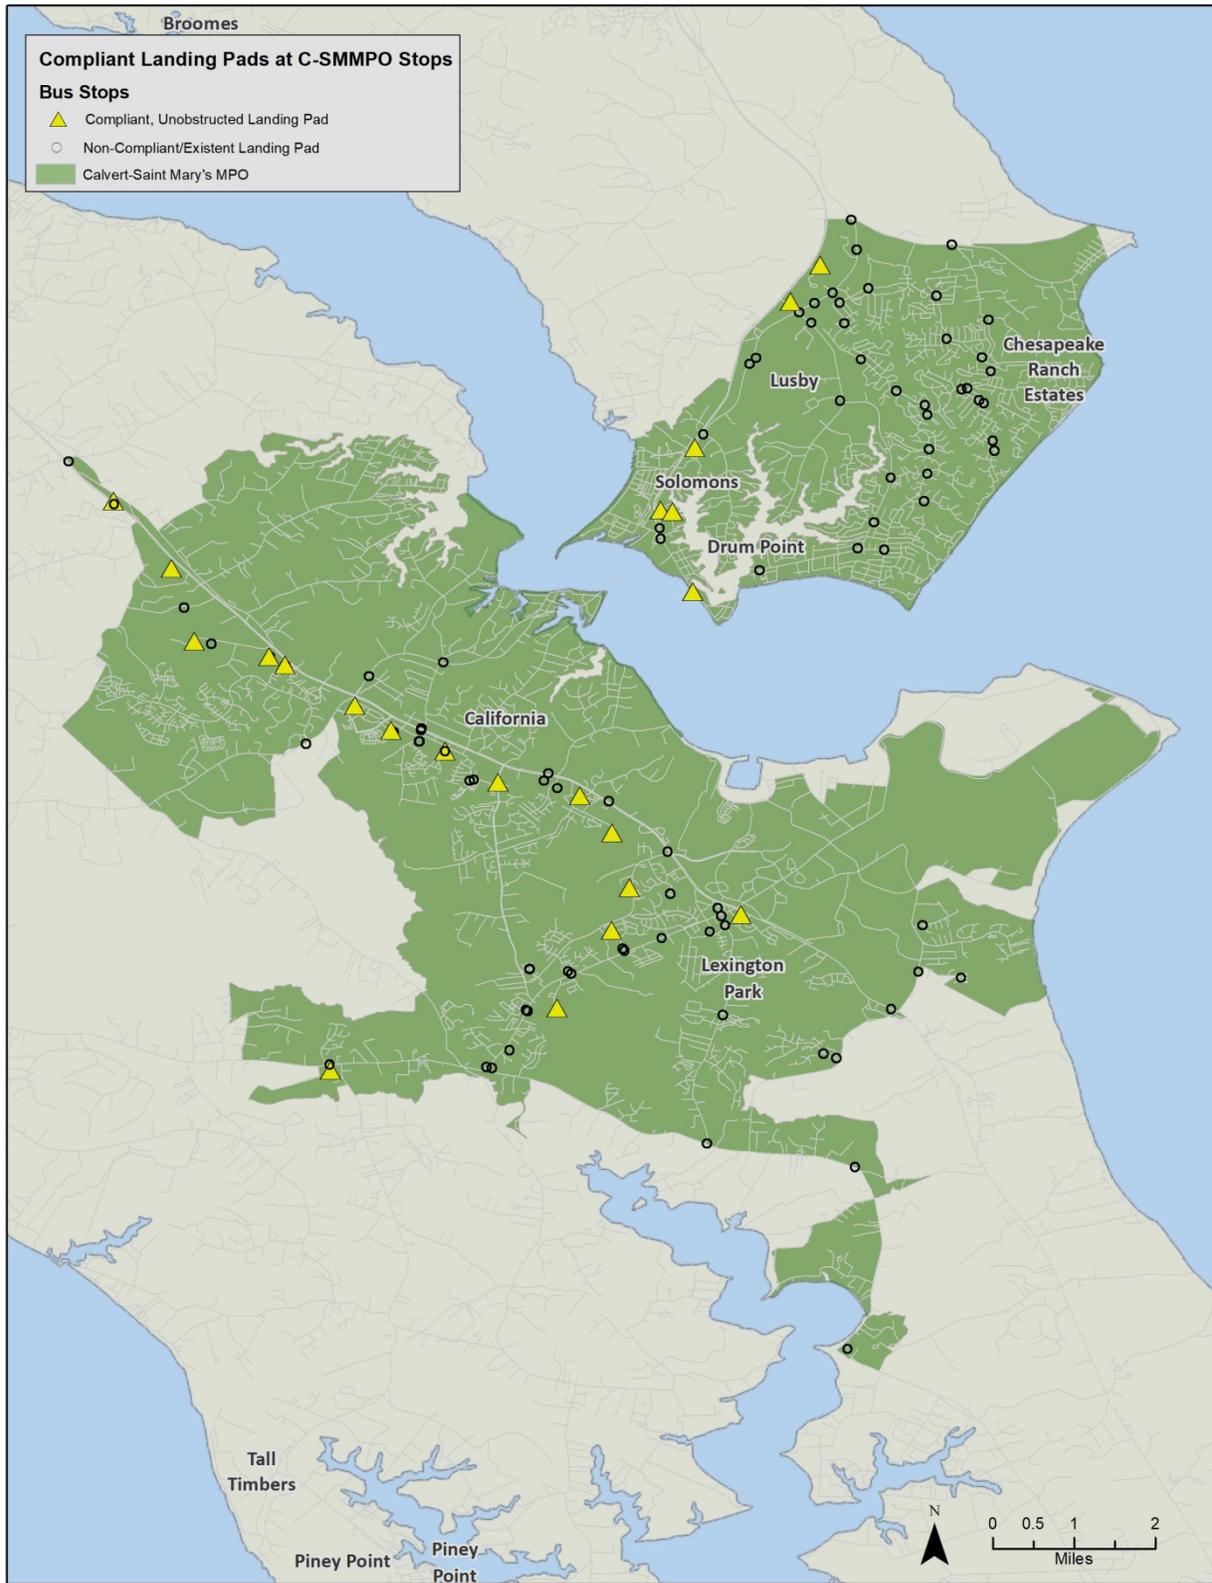
Figure 2-3: Compliant Landing Pads within the C-SMMPO

In total, 21 of the 111 bus stops (18.9%) had an unobstructed landing pad that was connected to both the curb and a paved walkway. Further details about the inventoried landing pads can be found in Table 2-4. Figure 2-3 maps all ADA Compliant Landing Pads within the MPO.

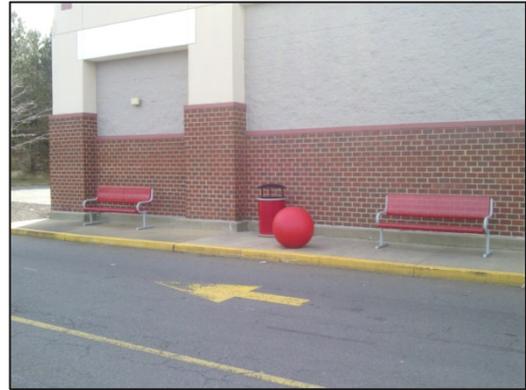
A total of 17 (15.3%) of the surveyed stops have at least one bench for waiting riders. Twelve (12) of the benches are freestanding, while the remaining five were located under a shelter. None of the inventoried benches had any damage. Most bench stops were located at important shopping centers like the California Target and the Lusby Giant. Table 2-5 includes detailed statistics about the observed benches.

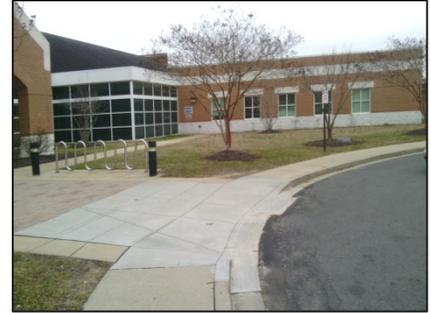
Some bus stops have other amenities in addition to information cases, benches, and shelters. Trash cans, the most common of these amenities, were present at 17 (15.3%) bus stops. Beyond trash cans, four (3.6%) stops had bicycle racks and one (0.9%) had publication boxes. Table 2-6 breaks down the distribution of these amenities at the inventoried stops.

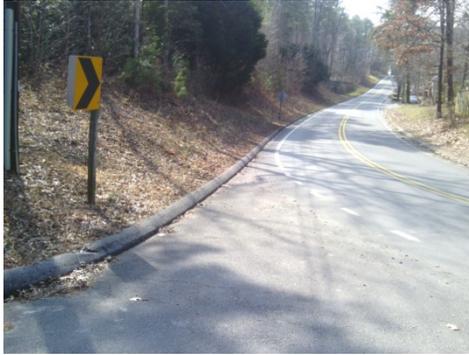
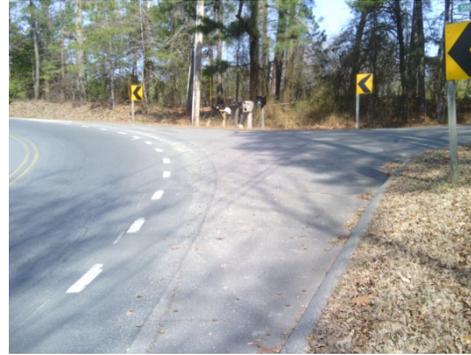
The stop at Catalina Drive & Sandy Wash Circle is located in Chesapeake Ranch Estates at an intersection that is on a sharp bend in the road with limited visibility for drivers in either direction. While the shoulder widens at these locations, there are no sidewalks or designated waiting areas for riders. The winding street design and narrow shoulders in Chesapeake Ranch Estates make it difficult to designate safe bus stops. Stops similar to this one were common in Chesapeake Ranch Estates. Due to the residential zoning in Chesapeake Ranch Estates, it may be difficult to make major improvements to some of the less safe stop locations.

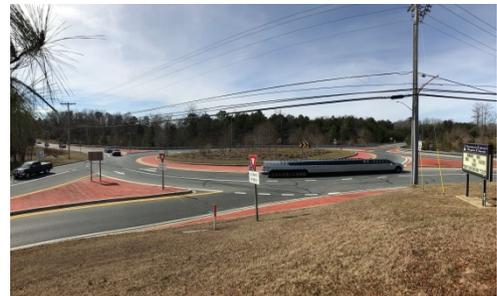
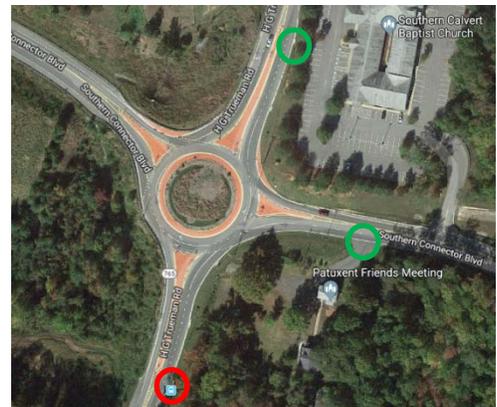
H.G. Trueman Road & Southern Connector Boulevard

This stop, located on the way from Lusby to Solomon's Island is recorded in the GIS as stopping on the nearside of the traffic circle when heading northbound. The speed limit on H.G. Trueman is 50 mph heading northbound, and the stop location which is listed on Google Maps (red circle on bottom right image) is on a narrow shoulder with limited visibility for both drivers and riders. The listed location is unsafe for boarding. The surveyor further examined the intersection and notated a safer potential stop location (green circles on the bottom right image) on the farsides of the traffic circle that would allow for a safer boarding process.

Since most stops are flag stops, directing people to wait for the bus at locations that are safe and visible is extremely important. If somebody at the two nearby churches wanted to board the bus and used their phone to identify the bus pick-up point, it would direct them to cross an intersection without pedestrian walkways and wait on the side of a high-speed road with a narrow shoulder and limited visibility for both drivers and pedestrians.
