Technical Memorandum 4

Recommended Improvements

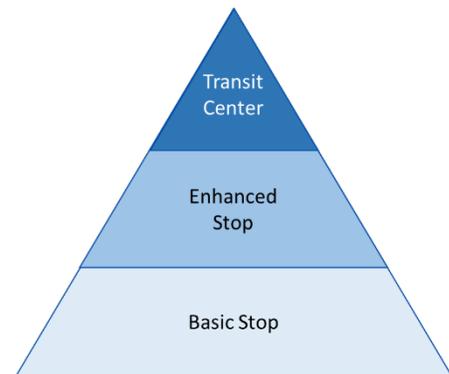
Figure 4-1: Bus Stop Categorization
The pyramid shape symbolizes the building blocks for bus stop improvements

Each bus stop was classified as one category; however, the nature of the categorization builds upon the lower category (see Figure 4-1). For example, a bus stop that is classified as an enhanced stop must include the basic bus stop improvements before enhanced passenger amenities are installed. Utilizing this approach, the following sections summarize improvement types rather than stop classification.

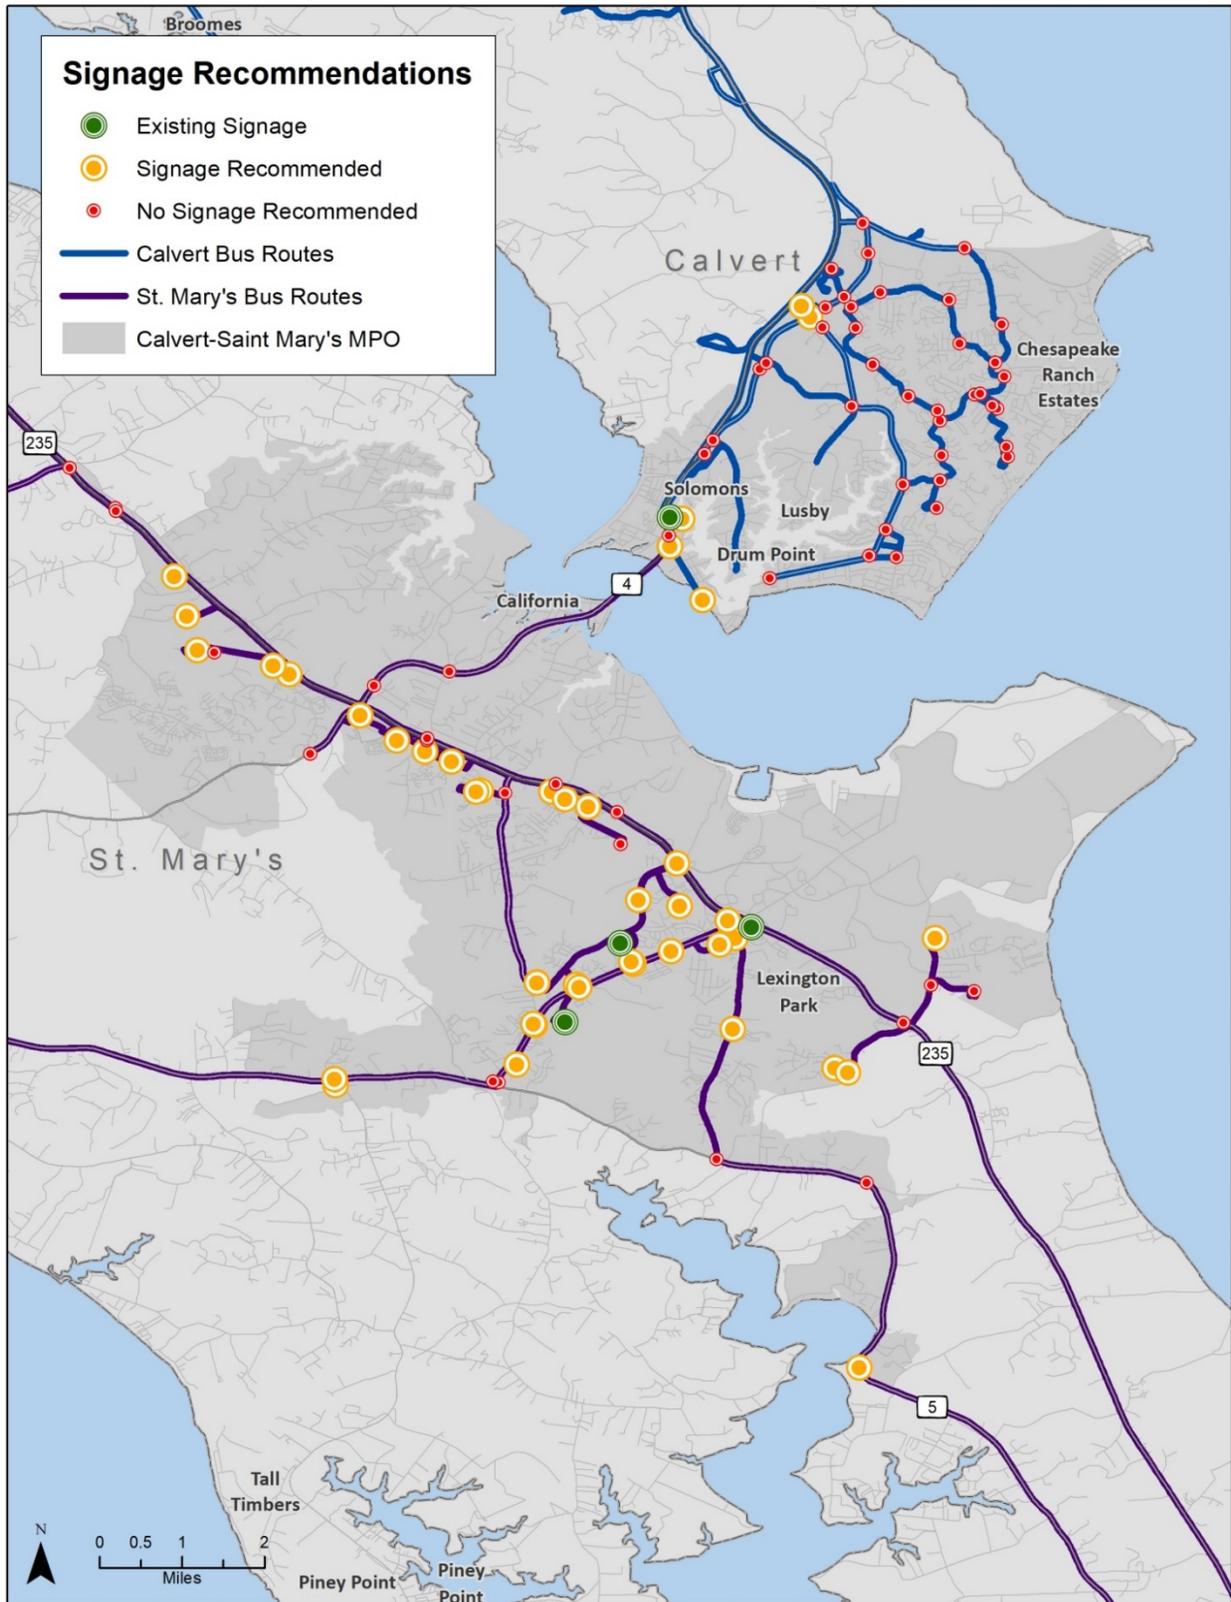
Figure 4-2: Recommended Bus Stop Signage throughout CSM-MPO

CCPT and STS heavily utilize flag-stop systems. There are currently only four signed bus stops within the MPO study area; one in Calvert County and three in St. Mary's County. Following the five daily boardings threshold, bus stop signage is recommended at 43 of the identified bus stops (see Figure 4-2).

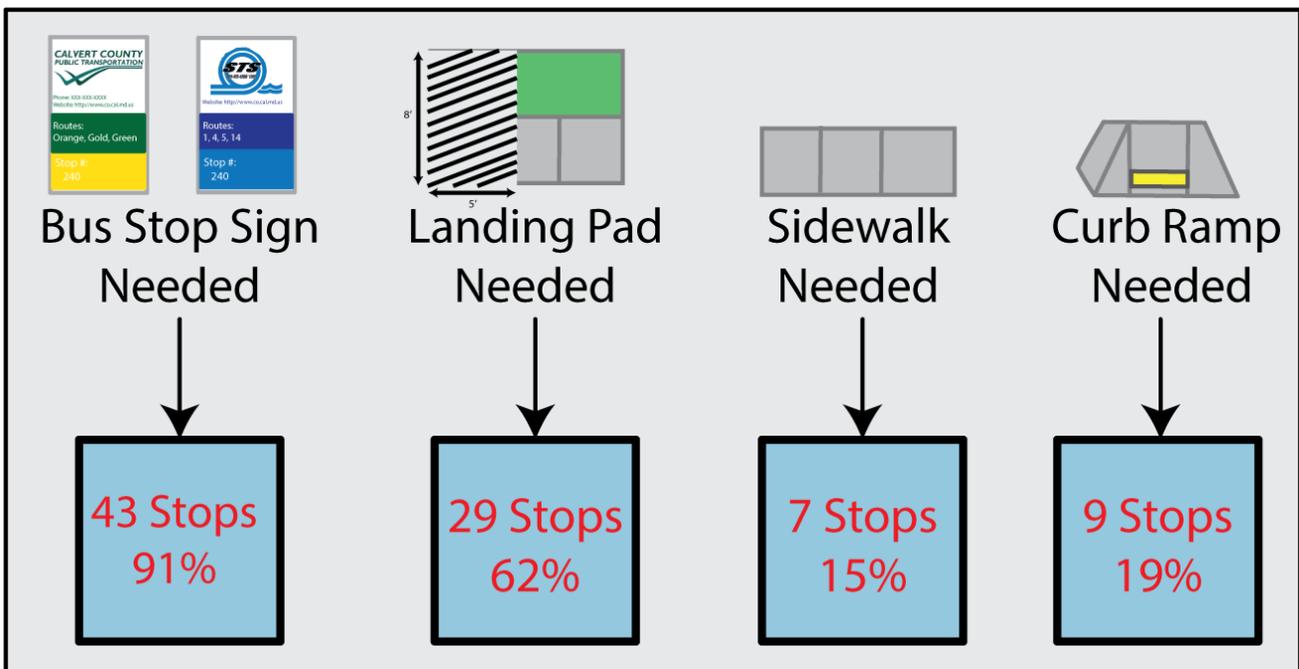
Figure 4-3: Basic Bus Stop Improvement Summary

Implementing these improvements will lead to ADA compliance at each bus stop. The improvements will also provide a safe and inviting experience for transit customers; especially individuals who rely on mobility assistance devices. A total of 47 bus stops were identified for recommended basic bus stop improvements. Figure 4-3 summarizes the number of improvements needed at the basic bus stops within the MPO.

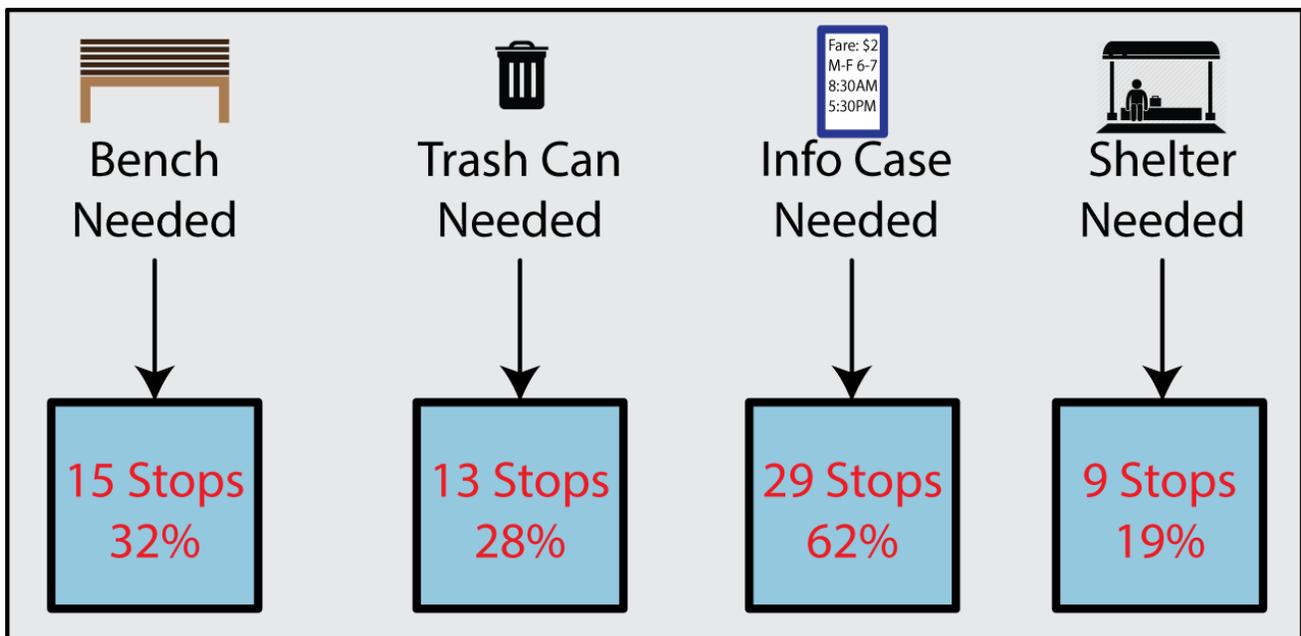
Figure 4-4: Enhanced Bus Stop Improvement Summary

Figure 4-4 displays the number of necessary improvements to improve enhanced bus stops in the region. Appendix B contains a table showing the improvements required at each individual enhanced bus stop.

Many enhanced bus stops still need basic improvements. Of the 29 enhanced stops recommended for improvements, 14 require an ADA compliant landing pad, 1 stop lacks a curb ramp and 13 stops require an updated curb ramp with a detectable warning.

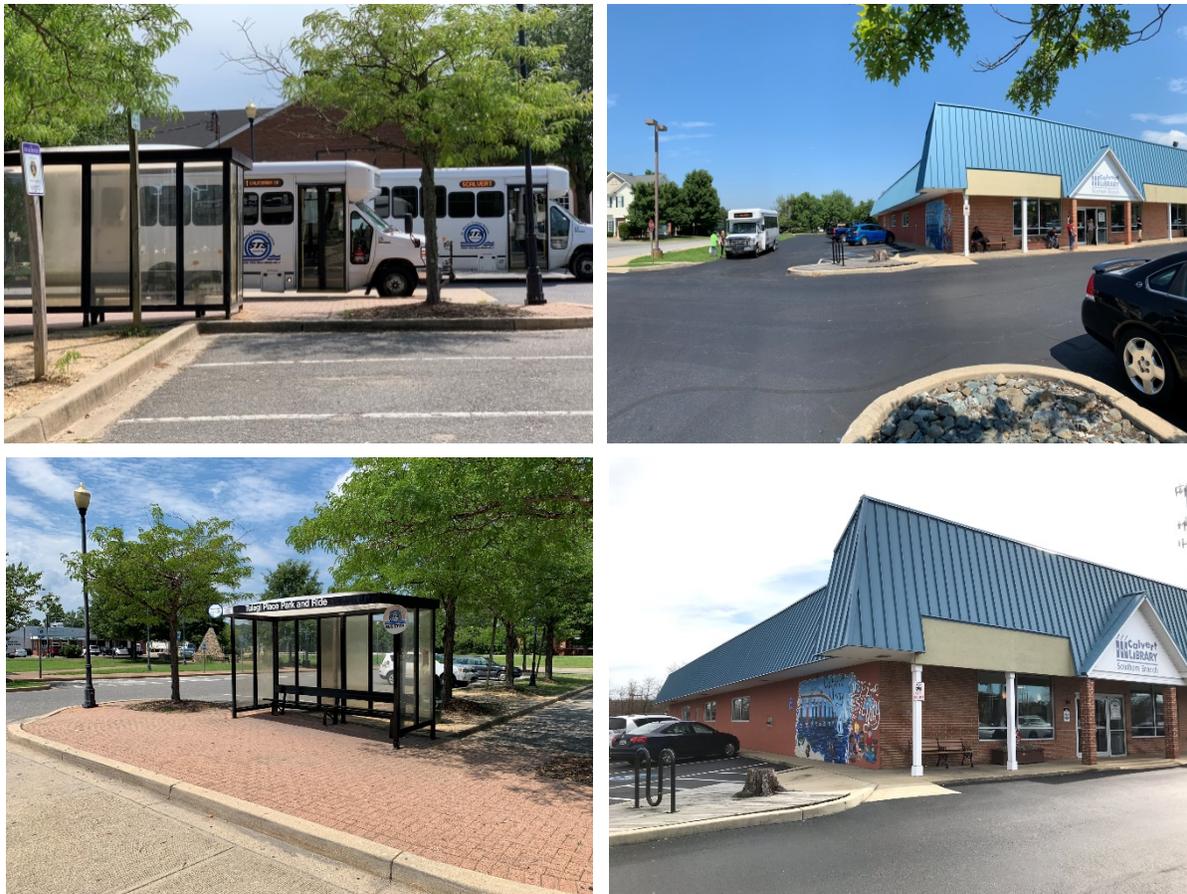
Figure 4-5: Tulagi Place (Left) and Calvert Southern Library (Right) On-Site Images

Shown in Figure 4-5, Tulagi Place already has a shelter and an accessible landing pad but requires a new detectable warning and information cases. The Calvert Southern Library's overhang acts as a shelter; however, the stop would benefit from an information case, detectable warning, and trash can.

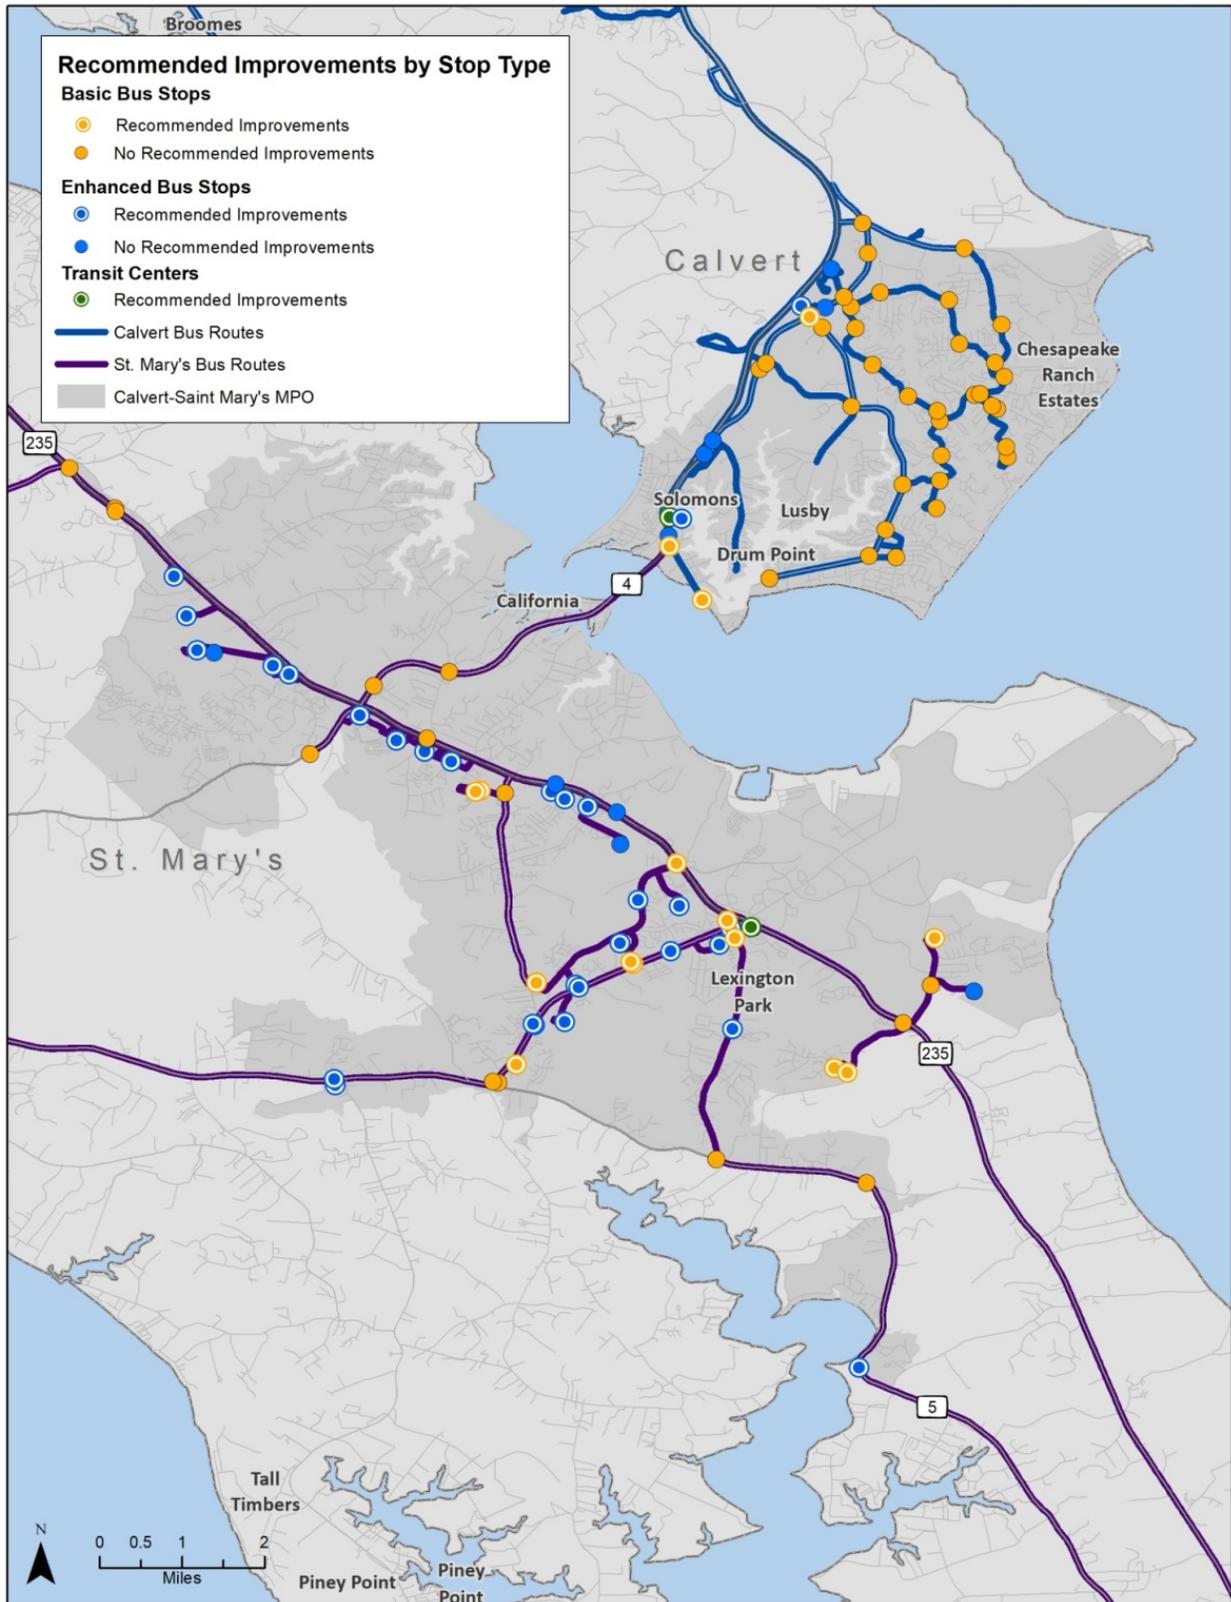
Figure 4-6: Recommended Improvements by Bus Stop Categories

Figure 4-6, on the following page, provides an overview of the recommended bus stop improvements broken down by bus stop categories.

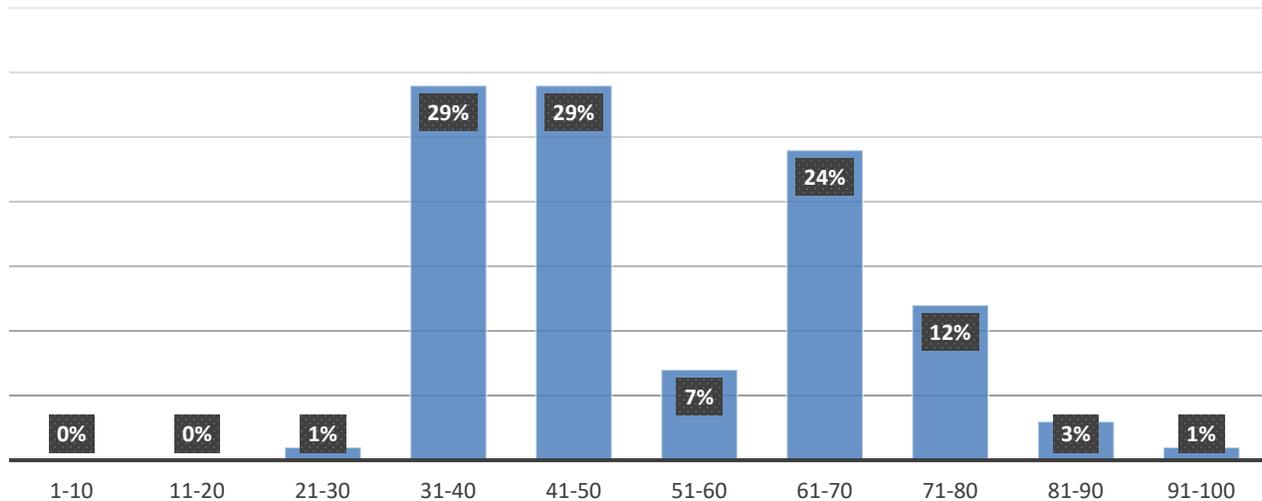
Figure 4-7: Distribution of Prioritization Scoring

The prioritization index generated a 1 to 100 prioritization score; with 100 being the highest priority. The distribution of the scores, shown in Figure 4-7, ranged from 21 to 91 with the majority of stops falling into the 31 to 50 range. The top 10 bus stops with the highest prioritization scores are shown in Table 4-2.

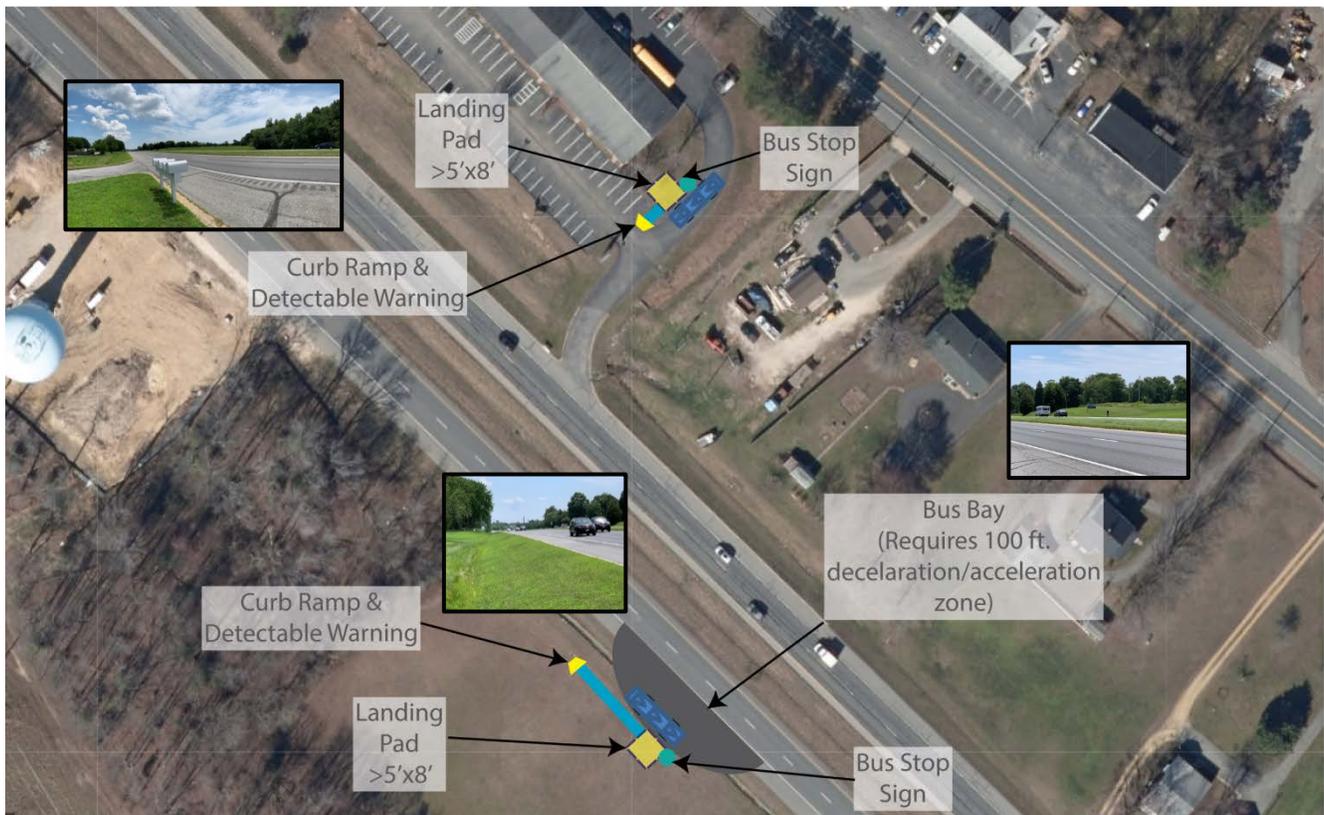
Figure 4-10: Hollywood Medical Center/Three Notch Road Improvement Diagram

Figure 4-10 shows two stops located on Three Notch Road in Hollywood, where the speed limit is 55 mph. The northbound stop can turn into a parking lot, turn around, and pick up any riders. The southbound stop does not have anywhere to turn in, so the expansion of the shoulder or creation of a bus bay along the shoulder would be the best way to make the stop safer. Figure 4-10 also includes on-site pictures, showing both stops and a bus passenger beginning to cross the road after getting off an STS bus.

- Turning off the high-speed road and into the desired destination
- Building an expanded road shoulder or bus bay that gives the bus proper space for safe deceleration, boarding/alighting, and acceleration

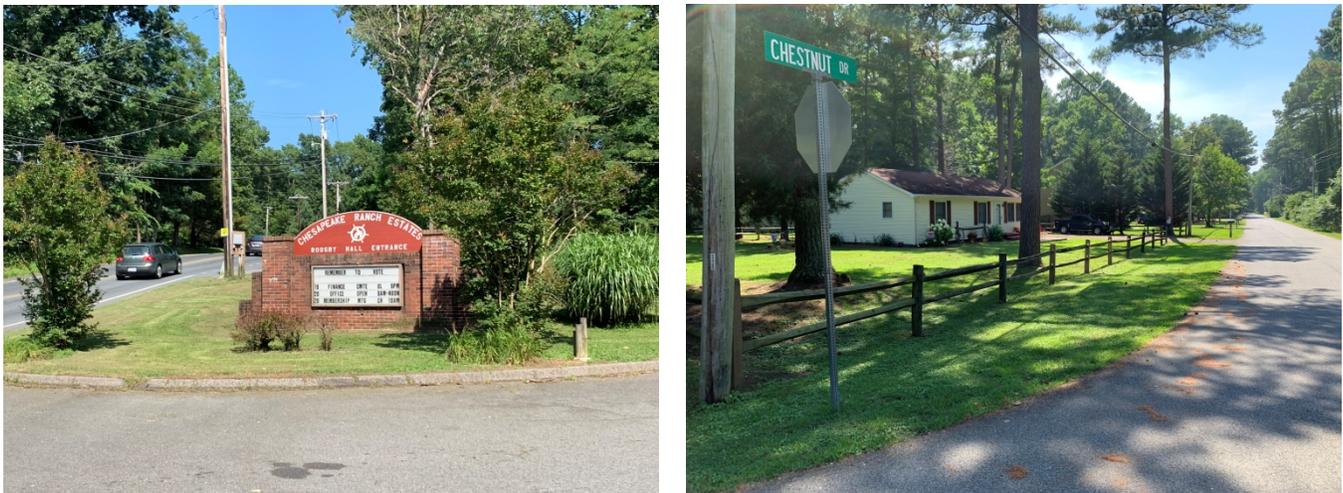
Figure 4-12: Chesapeake Ranch Estates Residential Bus Stops

A constant barrier to transit expansion and improvements is a “not in my backyard”, or NIMBY, attitude. This attitude is most often expressed in lower-density single-family residential areas, such as Chesapeake Ranch Estates. This neighborhood, which contains a bulk of Calvert County’s stops in the CSM-MPO, is entirely residential. The installation of signs at these stops would precipitate complex, and perhaps contentious, discussions and coordination between local residents, the homeowners association, and the transit provider. Since most surveyed bus stops in Chesapeake Ranch Estates are in front of single-family homes and on a road network that is circuitous and un conducive to basic bus stop improvements, it may be difficult to make any improvements in this area.
