Calvert-St. Mary's MPO Bus Stop Assessment and Plan Draft Final

August 2019

Calvert - St. Mary's
METROPOLITAN
PLANNING ORGANIZATION

KFH
◆ GROUP ◆

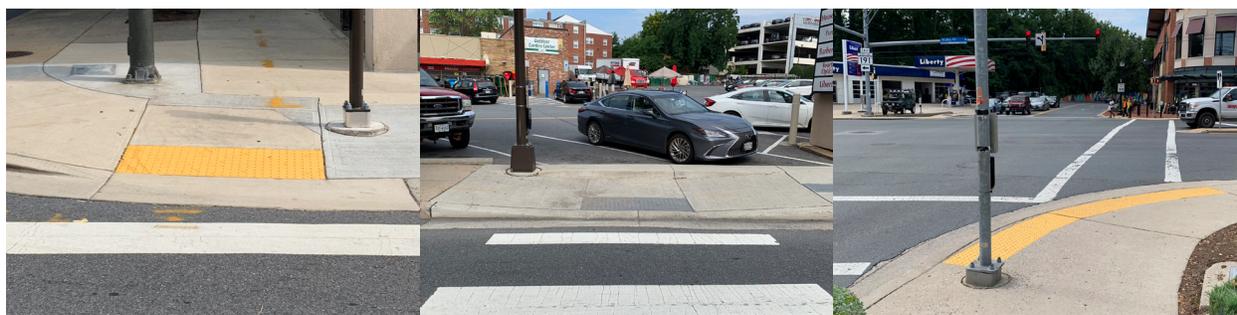
Figure 1-3: Examples of Curb Ramps and Blended Transitions

Perpendicular curb ramps are perpendicular to the street curb and permit pedestrians to cross the street perpendicular to vehicular traffic. Ideally, they are in line with the path of travel of both the sidewalk and the street crossing, but are not always possible within existing conditions. A common distinguishing feature of perpendicular curb ramps is that each ramp generally serves a single street crossing; at a four-way intersection, two perpendicular ramps are needed at each corner.

An alternative approach to curb ramps is a category of treatment referred to as a blended transition. A blended transition is a raised pedestrian street crossing, depressed corner, or similar level connection between the pedestrian pathway and the pedestrian street crossing. Blended transitions are commonly used in locations with high pedestrian activity.

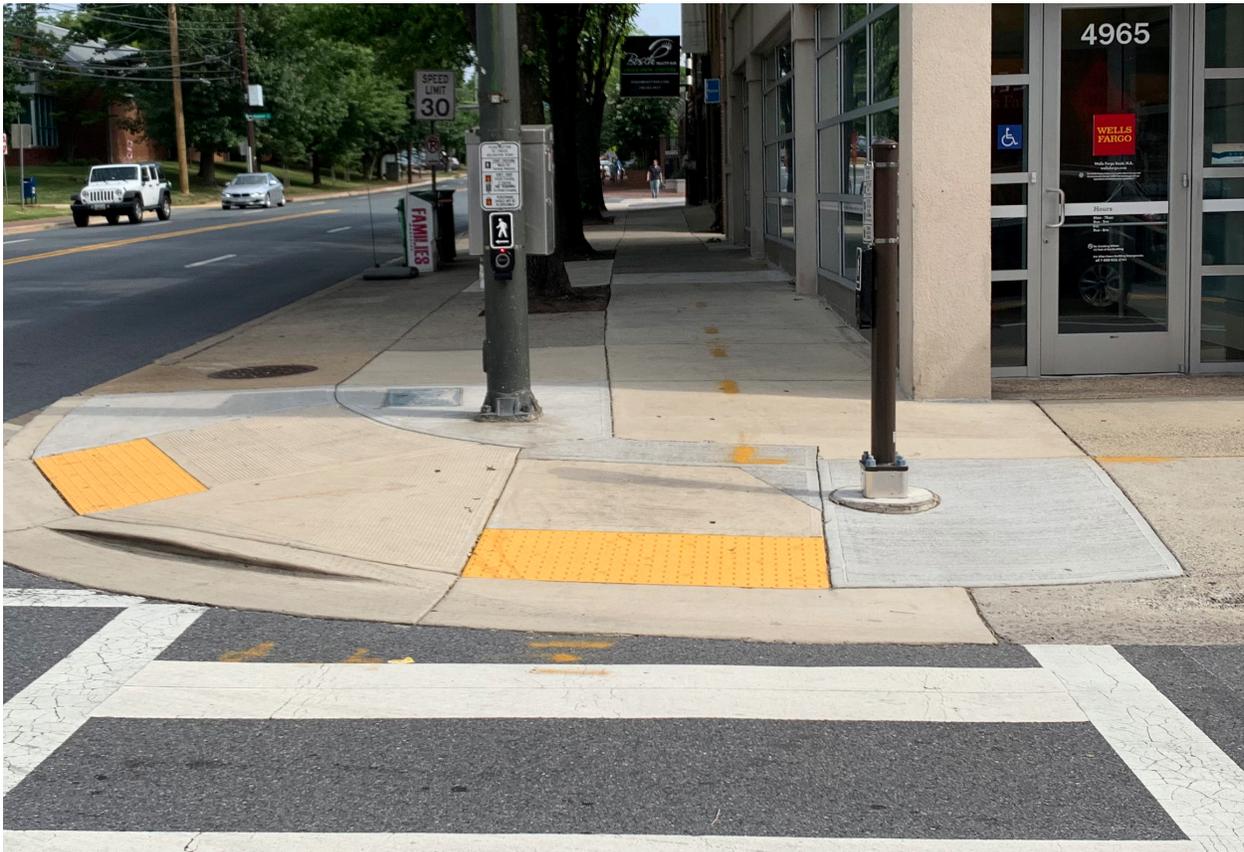
Figure 1-4: Example of Detectable Warning Surfaces

Detectable warning surfaces are not required at pedestrian refuge islands that are cut-through at the street level and are less than six feet in length in the direction of pedestrian travel.

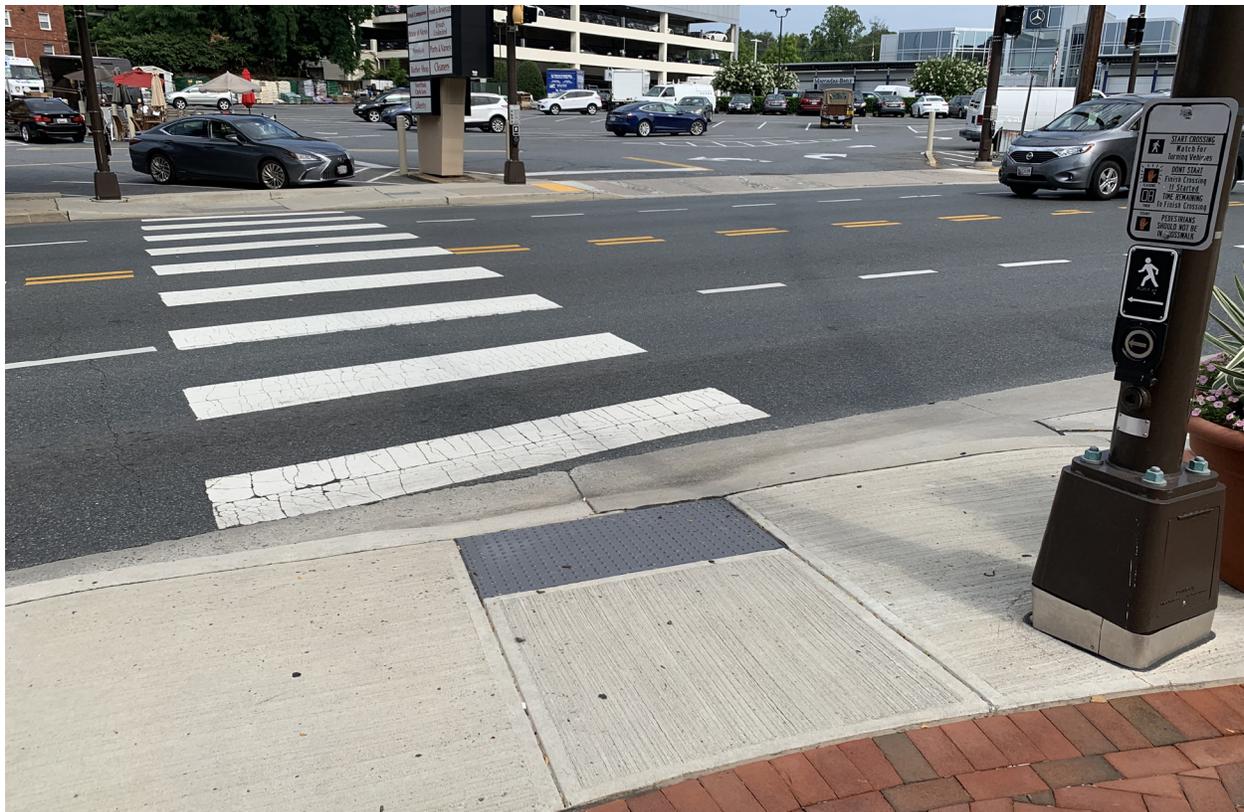
Figure 1-5: Example of an ADA Compliant Pedestrian Street Crossing

There needs to be a clear space adjacent to the pushbutton, connected to the pedestrian pathway, and the pushbutton must be mounted within a height range (15” to 48” from the surface) that makes it reachable for wheelchair users. The clear space must have a firm, stable, and slip resistant surface, with a running slope that is consistent with the grade of the adjacent pedestrian access route and a maximum cross slope of 2 percent. It must be a minimum of 48 inches by 30 inches and must be positioned to allow either forward or parallel approach to the pushbutton.

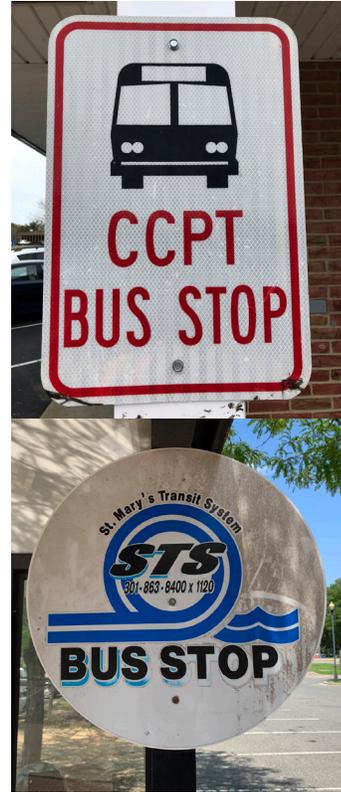
Figure 2-3: Bus Stop Signs

Of the 106 surveyed stops, only four had any signage indicating that the respective transit provider stopped there. Of the four, three of the stops were served by STS, while the remaining stop was served by CCPT. The three STS signs were attached to shelters, while the CCPT sign was attached to a column outside the Southern Branch of the Calvert County Library System. The rest of the stops were unmarked flag stops.

Shown in Figure 2-3, STS bus stop signs were more detailed than the CCPT signs, including a phone number and more noticeable branding elements. Having informative and distinctly designed signage makes both the bus stop and the transit system more visible and provides a direct line for customers to contact the transit agency with any questions or concerns about the system’s performance.

Under ADAAG bus stop sign compliance (see page 4), text characters cannot be italic oblique. Transit agency logos are typically excluded from this standard; however, the STS logo includes contact information (phone number) that is italic oblique. Both CCPT and STS should consider updating their bus stop signs with clear and enhanced branding.

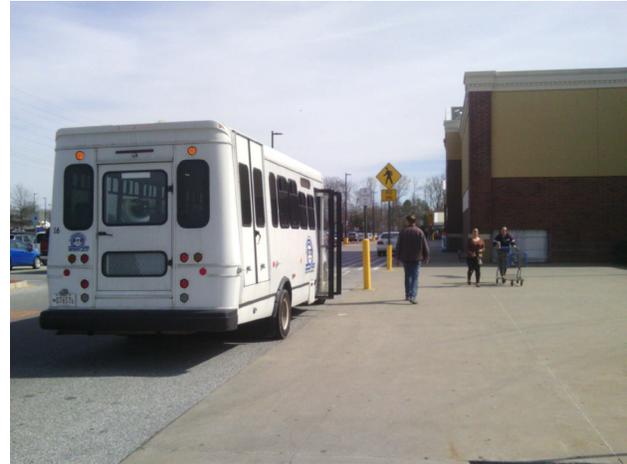
Figure 2-5: Landing Pad

In total, 22 of the 106 bus stops had an unobstructed landing pad that was connected to both the curb and a paved walkway. Further details about the inventoried landing pads can be found in Table 2-4.

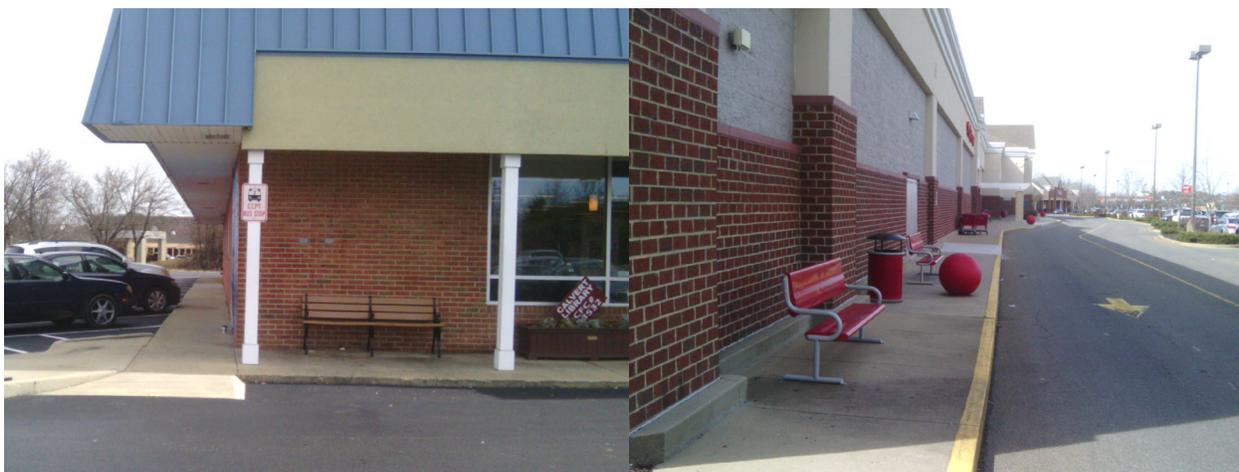
Figure 2-6: Bus Stop Benches

A total of 17 stops within the C-SMMPO have at least one bench for waiting riders. Twelve of the benches are freestanding, while the remaining five were located under a shelter. None of the inventoried benches had any damage. Most bench stops were located at important shopping centers like the California Target and the Lusby Giant. Table 2-5 includes detailed statistics about the observed benches.

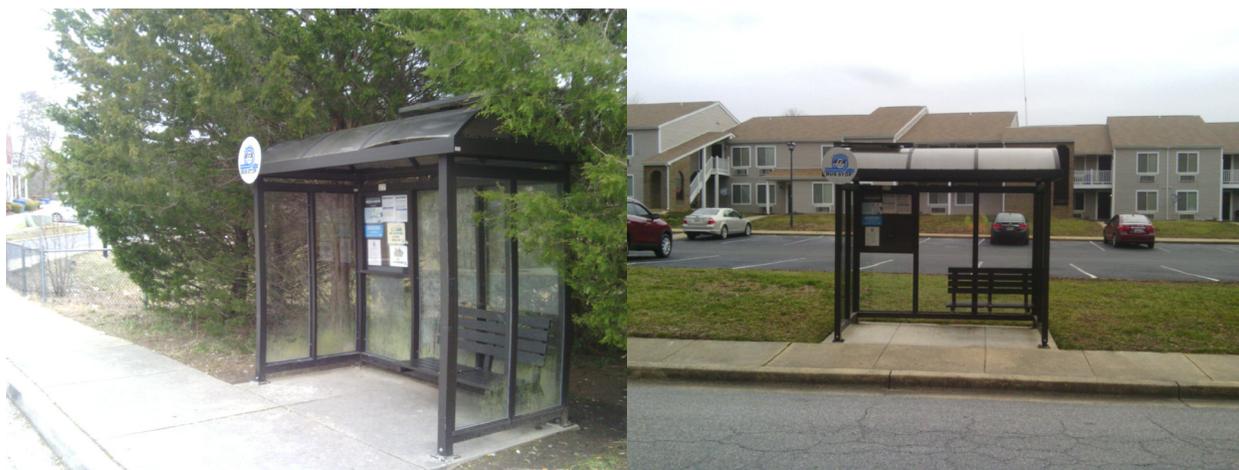
Figure 2-7: Bus Shelters

Five shelters were observed during the field survey. Each shelter featured interior seating, and three shelters had concrete foundations, while the other two had dirt or brick foundations. None of the shelters had any advertisements, and only one of the shelters had damage, from graffiti. One shelter was deemed inaccessible because its entrance was blocked by a bench. Table 2-6 outlines the statistics for the shelters observed during the survey.

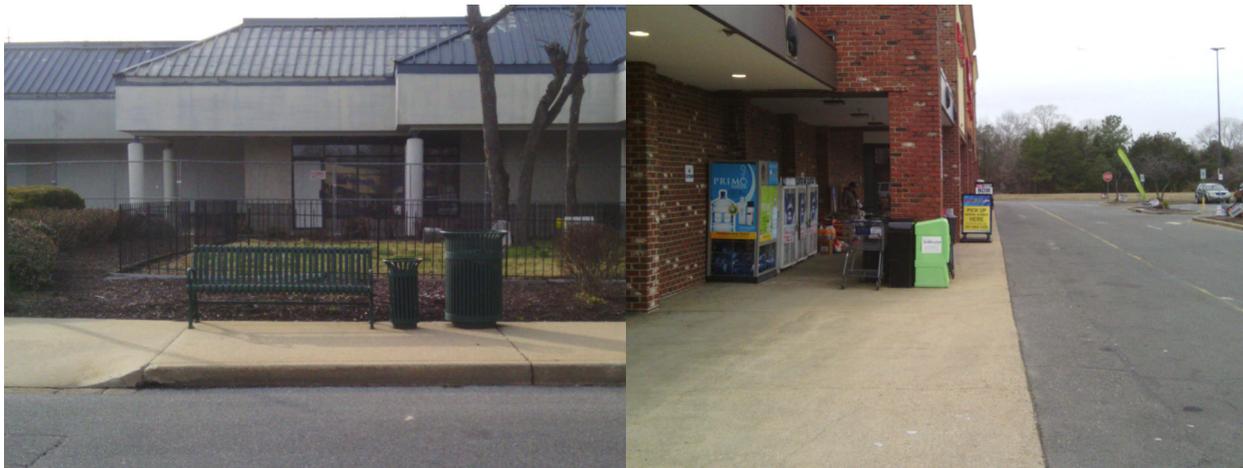
Figure 2-8: Other Bus Stop Amenities

Some bus stops have other amenities in addition to information cases, benches, and shelters. Trash cans, the most common of these amenities, were present at 16 bus stops. Beyond trash cans, four stops had bicycle racks and one had publication boxes. Table 2-7 breaks down the distribution of these amenities at the inventoried stops.

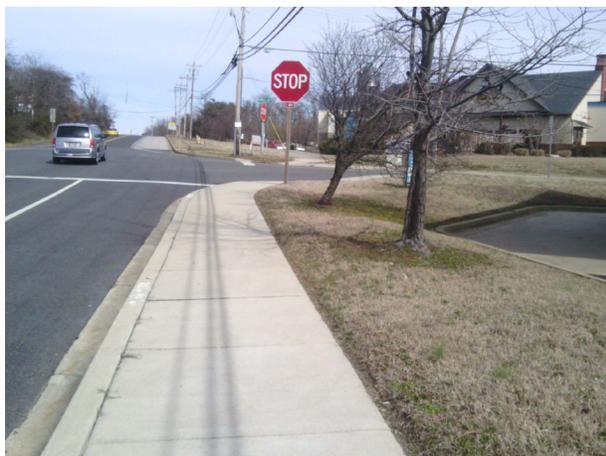
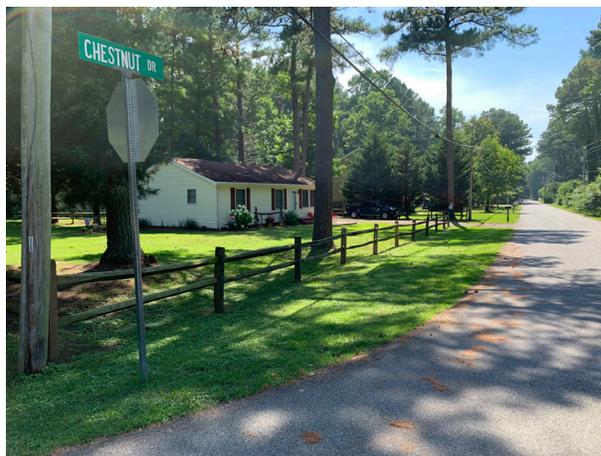
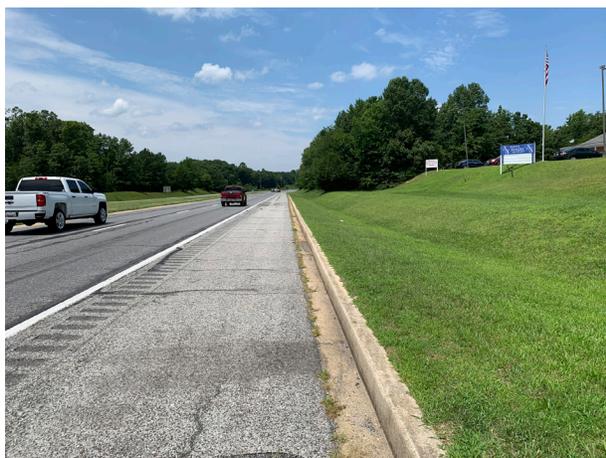
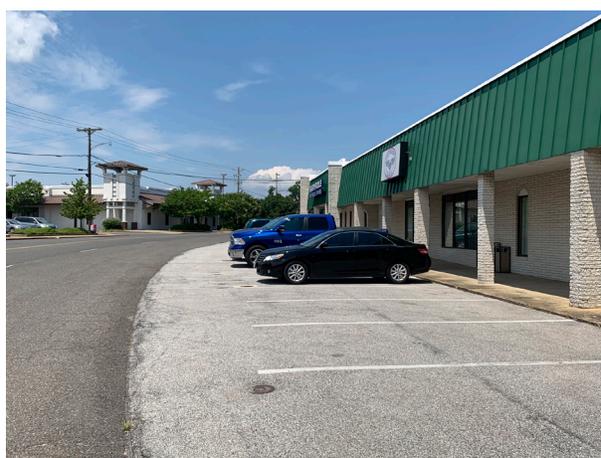
Figure 3-10: Basic Bus Stop Examples

A basic bus stop is simple in design, but should always provide a safe and accessible pedestrian connection (sidewalks, crosswalks, curb ramps, etc.), an ADA compliant 5' by 8' landing pad, and bus stop signage. Of the 106 observed stops in the C-SMMPO, 64 (60%) were categorized as basic bus stops.

Basic bus stops are typically found in low-density areas including single-family neighborhoods, smaller retail centers, and others. Heavy ridership or proximity to unique locations may necessitate additional passenger amenities including seating, trash cans, information cases, and shelters.

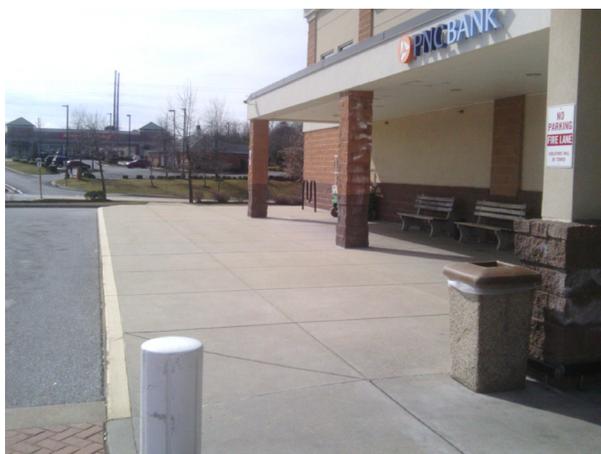
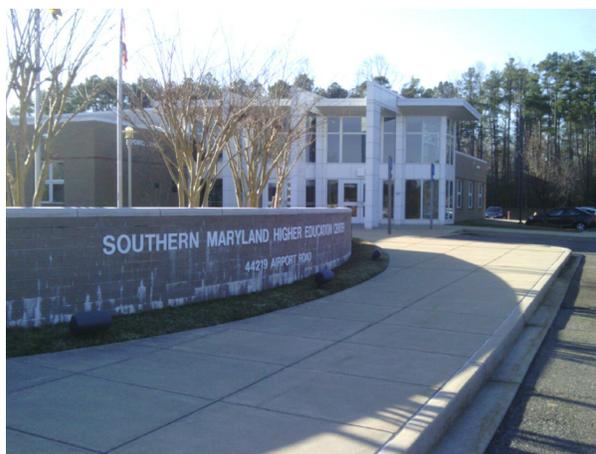
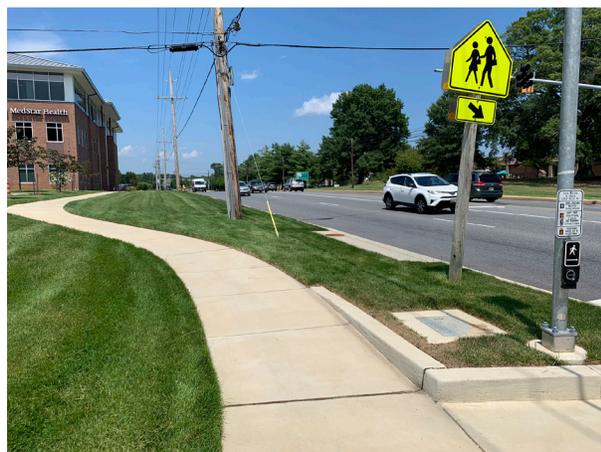
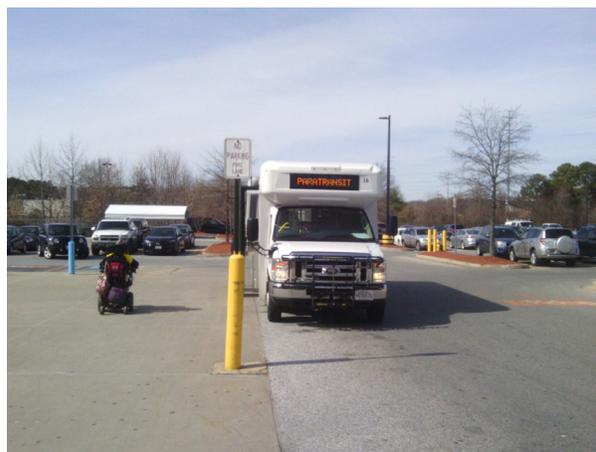
Figure 3-11: Enhanced Service Stop Examples

The observed enhanced stops were mostly located in and around shopping centers and community centers in Lexington Park and California. Of the 106 observed stops, 40 (38%) were considered to be enhanced bus stops.

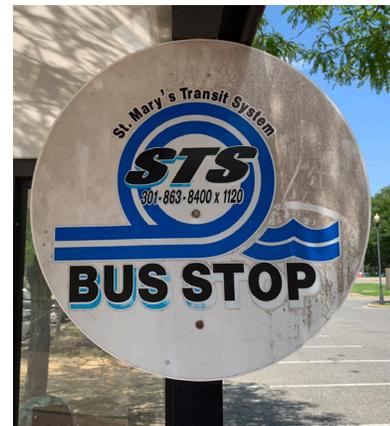
Figure 4-1: Updated Bus Stop Signs are Needed

Both CCPT and STS heavily utilize flag-stop systems. There are currently only four signed bus stops within the C-SMMPO study area; one in Calvert County and three in St. Mary's County. Following the five daily boardings threshold, bus stop signage is recommended at 43 of the identified bus stops (see Figure 4-2).

Installing bus stop accessibility improvements can be costly and time-consuming. Therefore, it is recommended that the local transit systems or jurisdictions install bus stop signage ahead of accessibility improvements given the current lack of signage. However, it should be stressed that the vast majority of these stops will not be compliant with ADA guidelines and an implementation plan should be in place to guide the future installation of accessibility improvements at these locations.

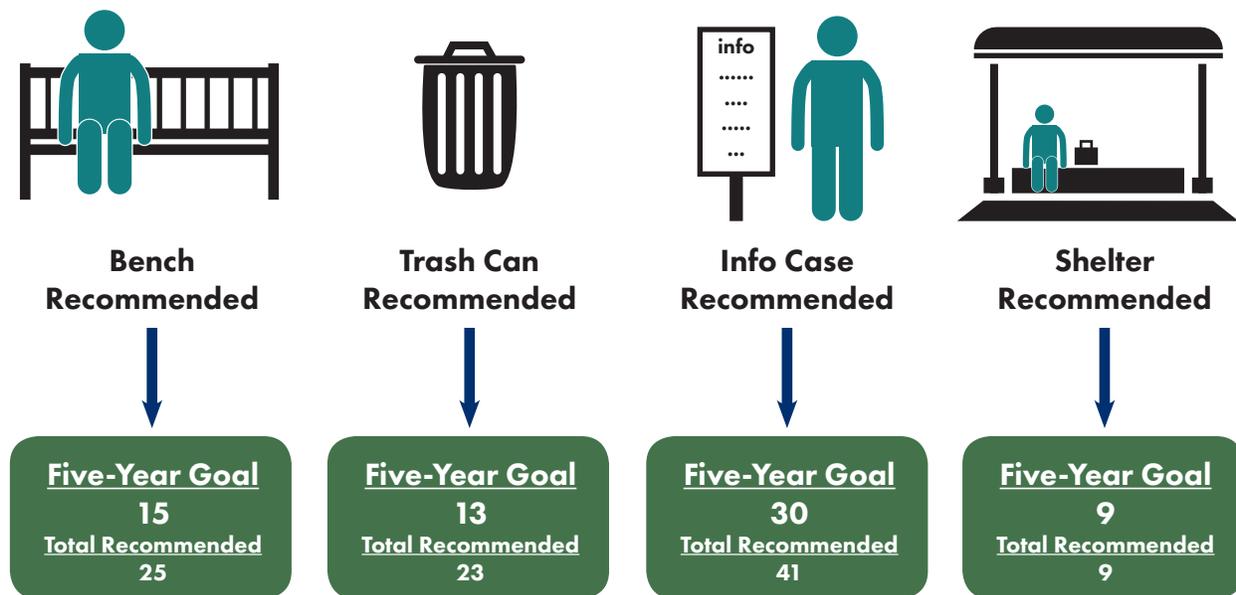
Figure 4-4: Enhanced Bus Stop Improvement Summary

Many enhanced bus stops still need basic improvements. Of the 29 enhanced stops recommended for improvements, 14 require an ADA compliant landing pad, one stop lacks a curb ramp and 13 stops require an updated curb ramp with a detectable warning.

Enhanced bus stops include additional customer amenities like seating and shelters. Amenities like benches, information cases, and trash cans should be placed at enhanced service stops whenever and wherever feasible. Bus shelters should be placed at bus stops that average 25 or more average daily boardings. Figure 4-4 displays the number of recommended improvements and sets a five-year goal for prioritized bus stops. Appendix B contains a table showing the improvements required at each individual bus stop.
